Libby, Montana
 Railyard Loading Station
 Asbestos Levels in Soil (by PLM)

LIBBY #2

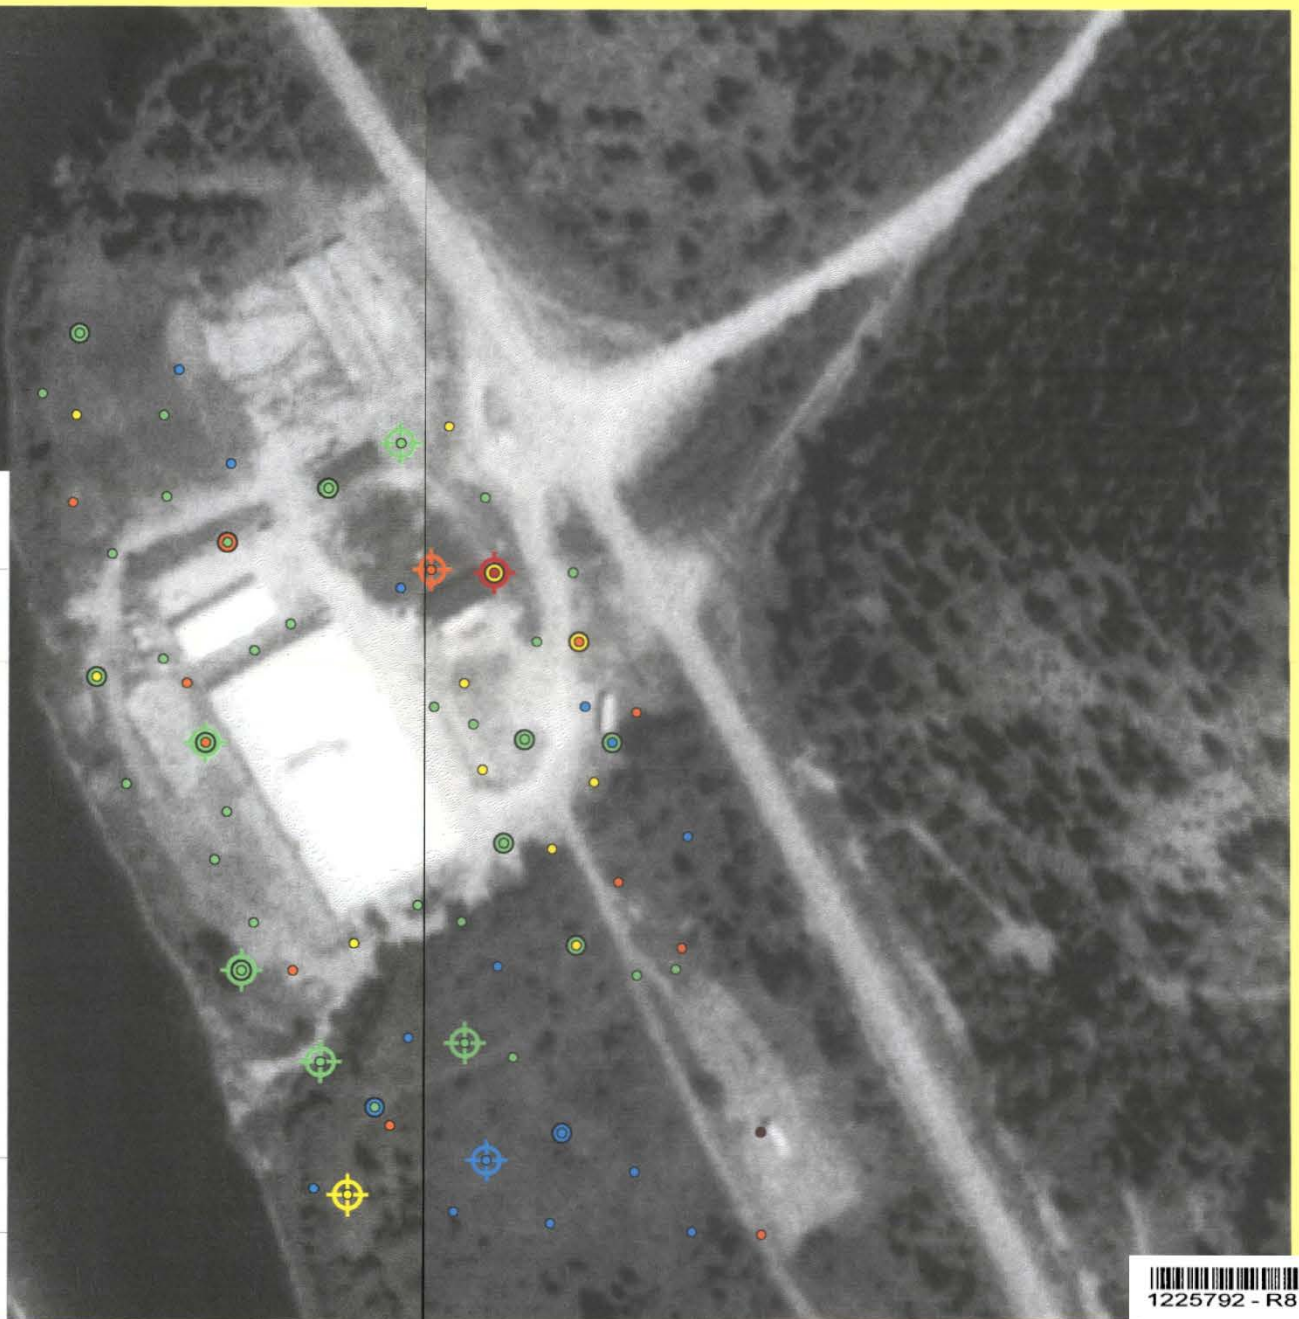
Field Samples

- ND
- <1%
- 1%
- 2%
- 3%
- 4%

Depth Sample Results

- ND
- <1 %
- 1 %
- 2 %

Duplicates

- ND
- <1 %
- 1 %
- 2 %
- 3 %

PLM Results Not Depicted

B00067 1% Tremolite-Actinolite
 B00075 <1% Tremolite-Actinolite
